Pre-restoration characteristics of upper Willow Creek Granite County Montana.

**Pre-Restoration Characteristics of Upper Willow Creek,
Granite County, Montana**

Michael Sanctuary

December 2002

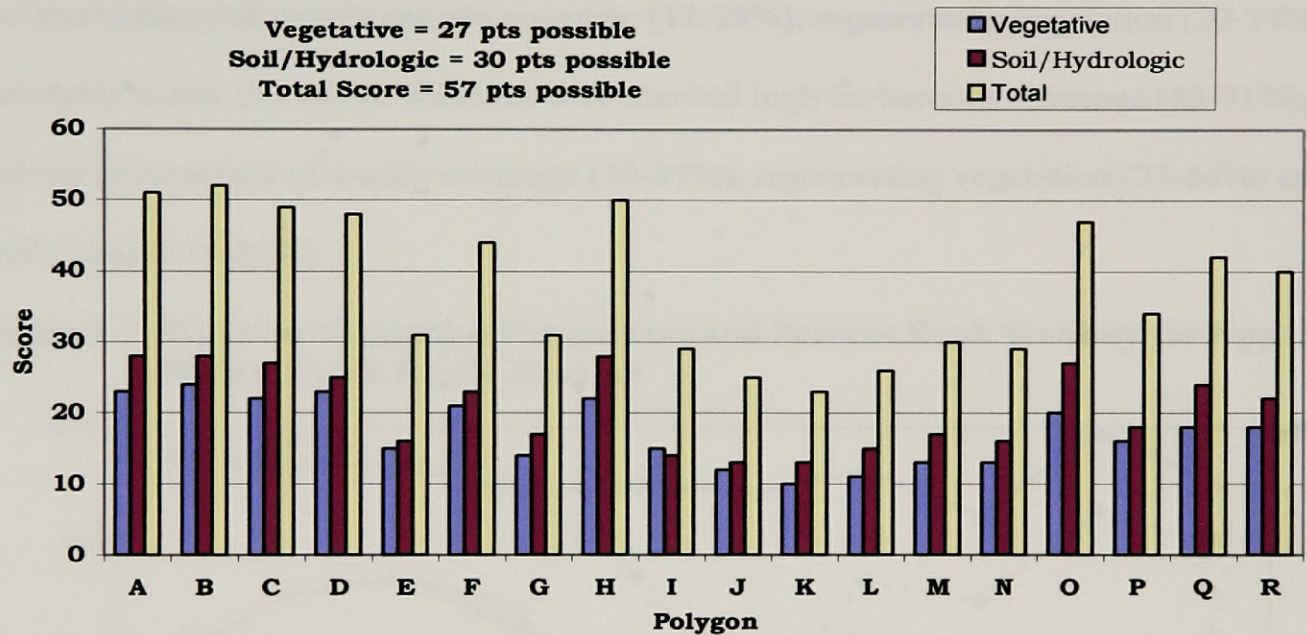
Figure 7 – RWRP Polygon Vegetative, Soil/Hydrologic and Total Scores for Upper Willow Creek

Polygons exhibiting non-functional ratings (<60) showed low scores in both vegetative and soil/hydrologic categories (Figure 7). Overall, Upper Willow Creek riparian health scored highest in upstream reaches (A-D), lowest in mid reaches (E-N) and fair health in lower reaches (O-R) (Figure 8).

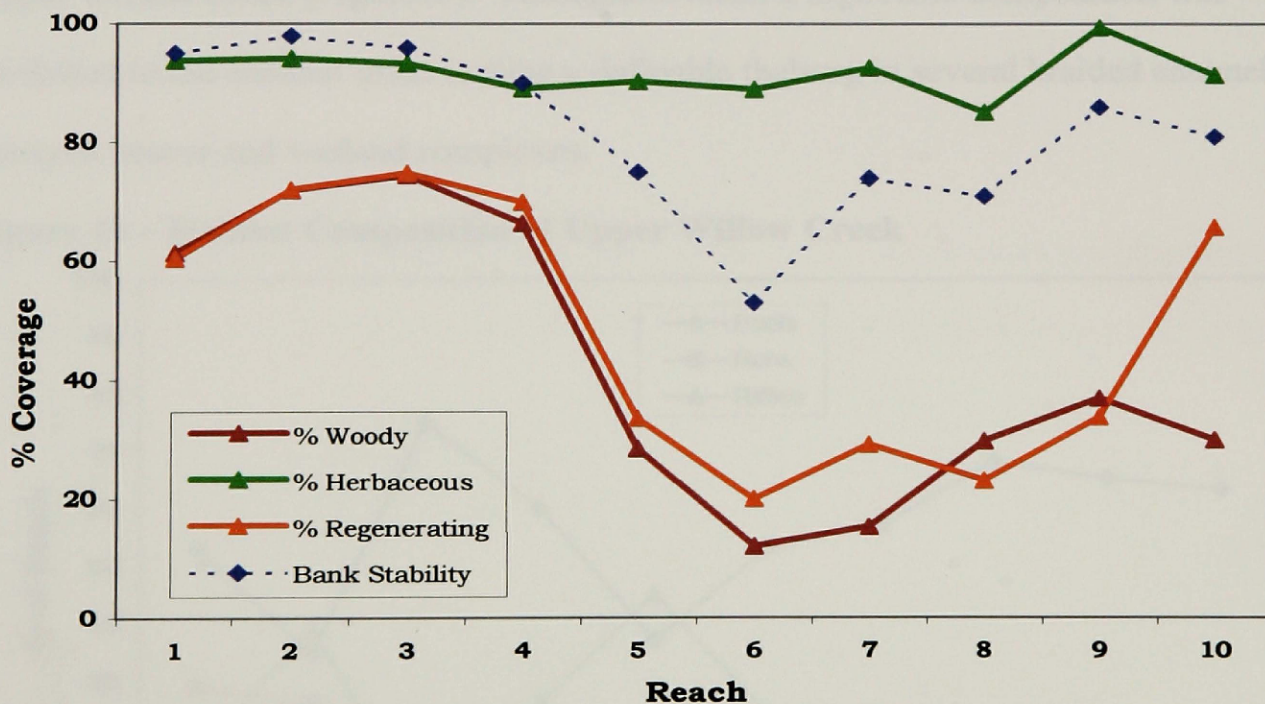
Figure 9 – Riparian Vegetation Component and Percent Bank Stability for Upper Willow Creek R1-R4 Reaches

Results from the R1-R4 inventory indicated variability for percent stable banks and vegetation coverage (Figure 9). Reaches 1-4 had high percentages of herbaceous cover (85-99%), woody species cover (61-74%), regenerating vegetation (60-75%) and percent stable banks (90-98%). Reaches 5-7 also had high herbaceous coverage (89-93%) but low percentages of woody species coverage (12-28%), regenerating vegetation (20-34%) and stable banks (53-75%). Reaches 8-10 showed high herbaceous coverage (85-91%), and fair percentages of woody coverage (30-37%), regenerating vegetation (23-66%) and stable banks (71-86%).

Percent woody and regenerating vegetation appears to correlate with percent stable banks throughout the length of Upper Willow Creek. Although herbaceous coverage remains high throughout all reaches, it does not appear to provide the bank-stabilizing root mass

capable of preventing banks from failing in reaches 5-8. The majority of woody species including willow, alder, chokecherry, woods rose and snowberry apparent in reaches 1-4 have either been heavily grazed or removed by chemical and physical means. The former landowner in reach 6 poisoned the riparian zone annually to provide increased grass and forb production (Bohrnsen 2001). Reaches 8-10 exhibited higher percent coverages of woody and regenerating species than reaches 5-7, as well as improved bank stability percentages. Although riparian shrubs appeared moderately grazed, most willows were mature and provided good bank-stabilizing root mass.

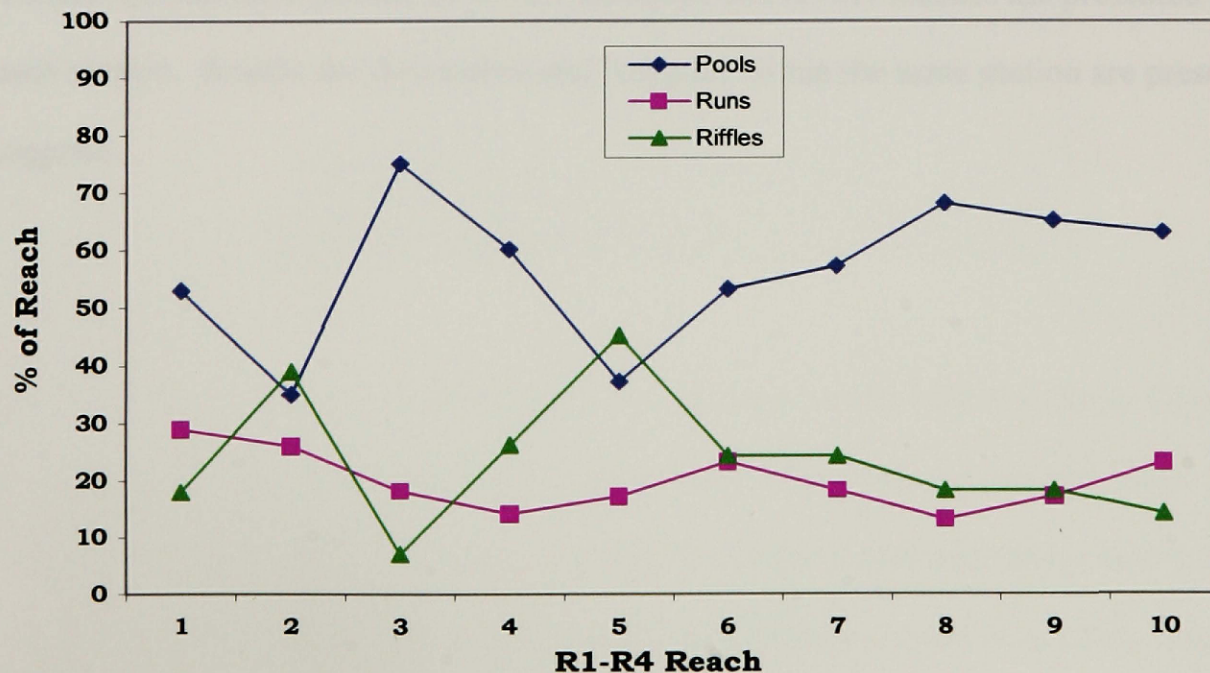
Figure 10 – Habitat Composition of Upper Willow Creek

Habitat composition (pools, runs and riffles) varied throughout R1-R4 reaches 1-10 of Upper Willow Creek (Figure10). Throughout reach 2 high riffle composition was attributed to the channel often lacking a definable thalweg in several braided channels between beaver and wetland complexes.

Reaches 5, 6 and 7 had lower percent pools due to alterations in channel morphology and riparian vegetation. Predominately natural sinuosity patterns in reaches 8, 9, and 10 caused pool composition to increase and riffle composition to decrease from reaches 5, 6 and 7.

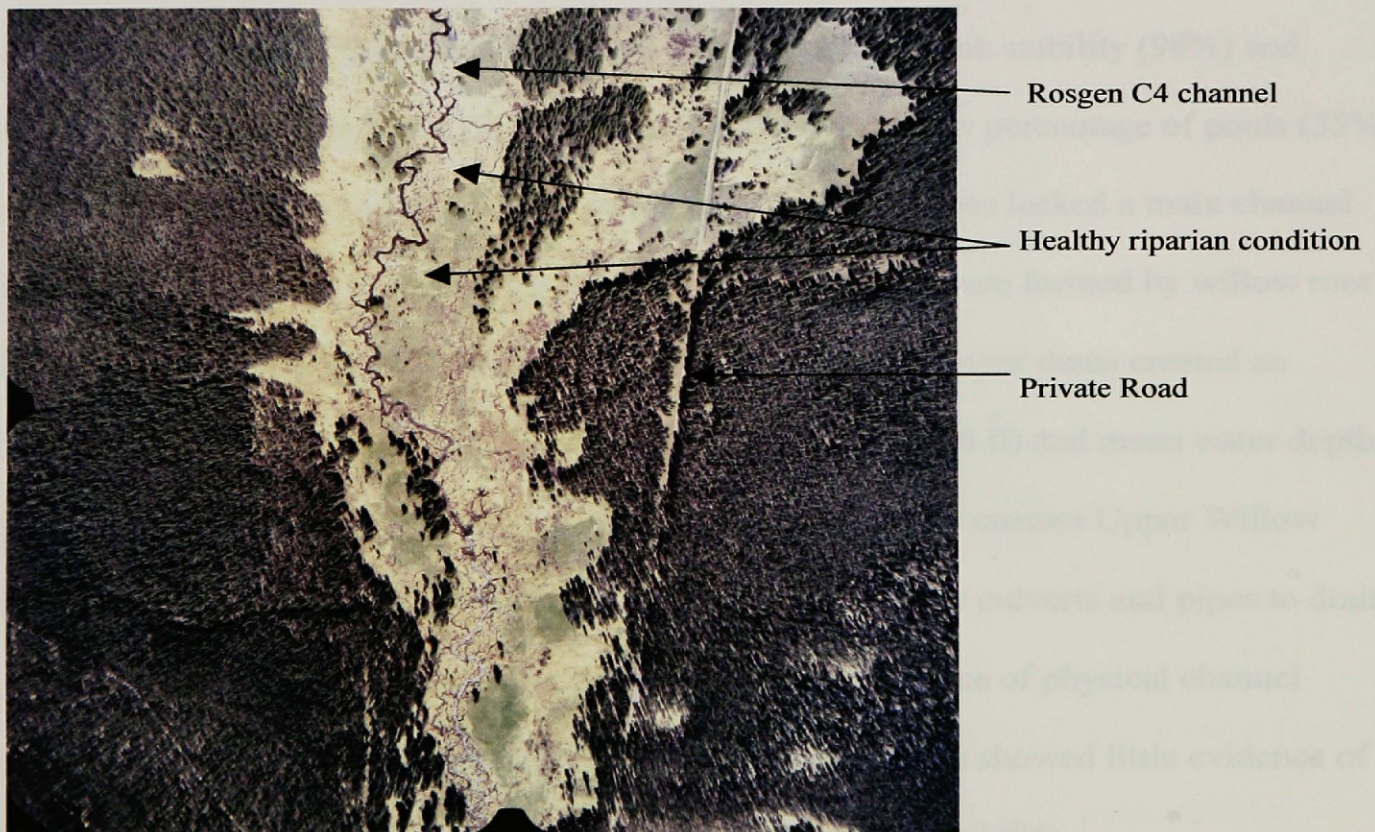
Figure 12 – Aerial Photograph over R1-R4 Reach 1 and RWRP Polygon A

Reach 1 (Figure 11 and 12) extended 7,373 feet between stream mile 0.0 (Shylo Creek) and stream mile 1.4 and included RWRP polygon A. This reach showed high bank stability (95%) and woody composition (61%). Pool/riffle ratios were lower in this reach compared to downstream reaches due to natural morphological conditions of the channel. Most pools were formed by willow root masses and meander scours (41% and 36%,

respectively). Beaver dams accounted for 19% of pool formations. Maximum pool depth (1.9 ft) and mean water depth (0.7 ft) provide adequate habitat for fish. This reach had no evidence of physical channel alteration.

This polygon scored high (89), indicating it is providing most riparian functions at a high level. Vegetative and soil/hydrologic scores suggested good conditions. Grazing pressure on preferred shrubs was light, and only short lengths were trampled and sheared by livestock. Exotic spotted knapweed (*Centaurea biebersteinii*) was present at the downstream boundary where Forest Service Road 88 crosses the creek. The downstream boundary of this polygon was defined by a series of culverts passing under the road.

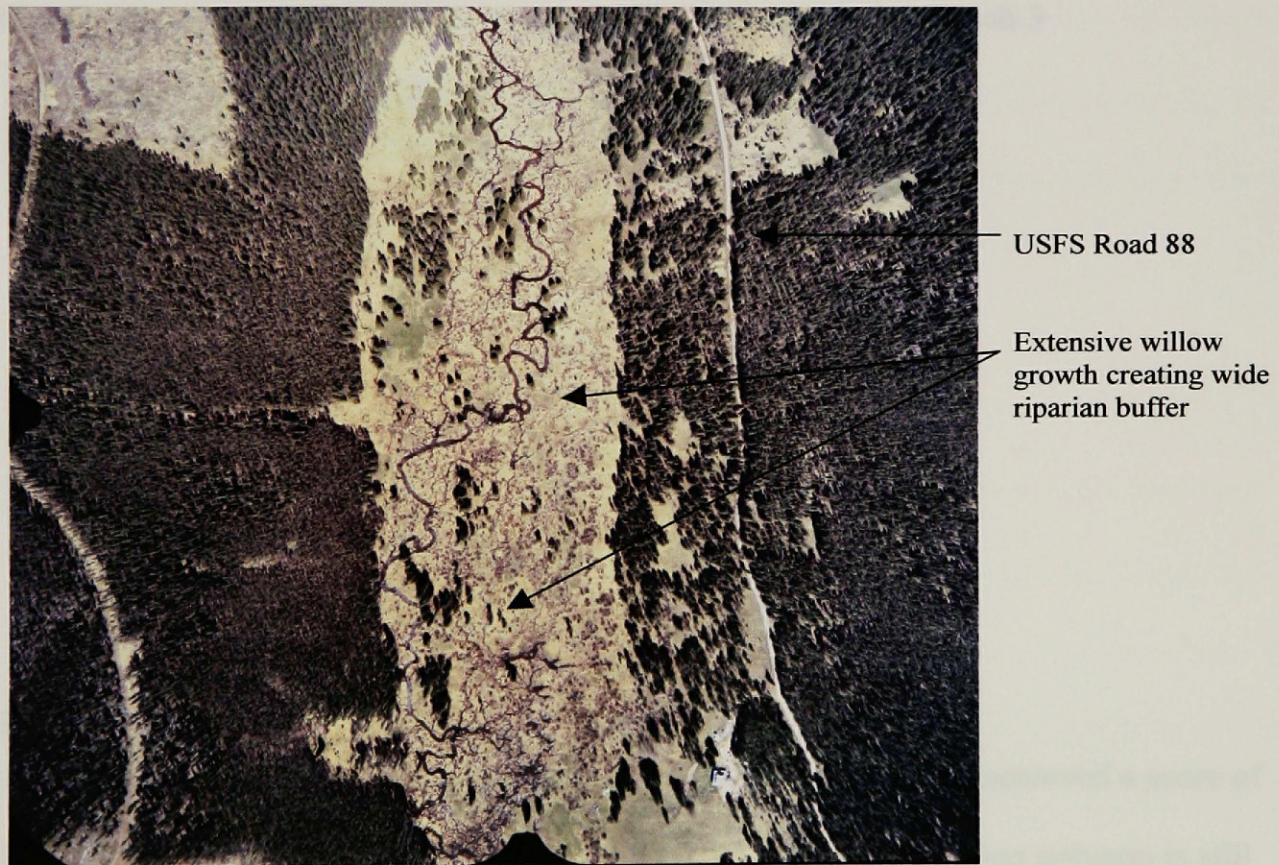
Figure 14 – Aerial photograph of a portion of R1-R4 Reach 2 and RWRP Polygon B

This polygon scored 91, the highest score of all polygons, and showed excellent vegetation and soil/hydrologic conditions. Grazing pressure was low, but some small areas were trampled by either livestock or wildlife. Channel conditions showed no evidence of lateral or vertical instability. Dense riparian vegetation throughout the polygon provided thermal protection and cover for fish. The polygon exhibited natural meanders, wide riparian zones and unaltered channels (Figure 14).

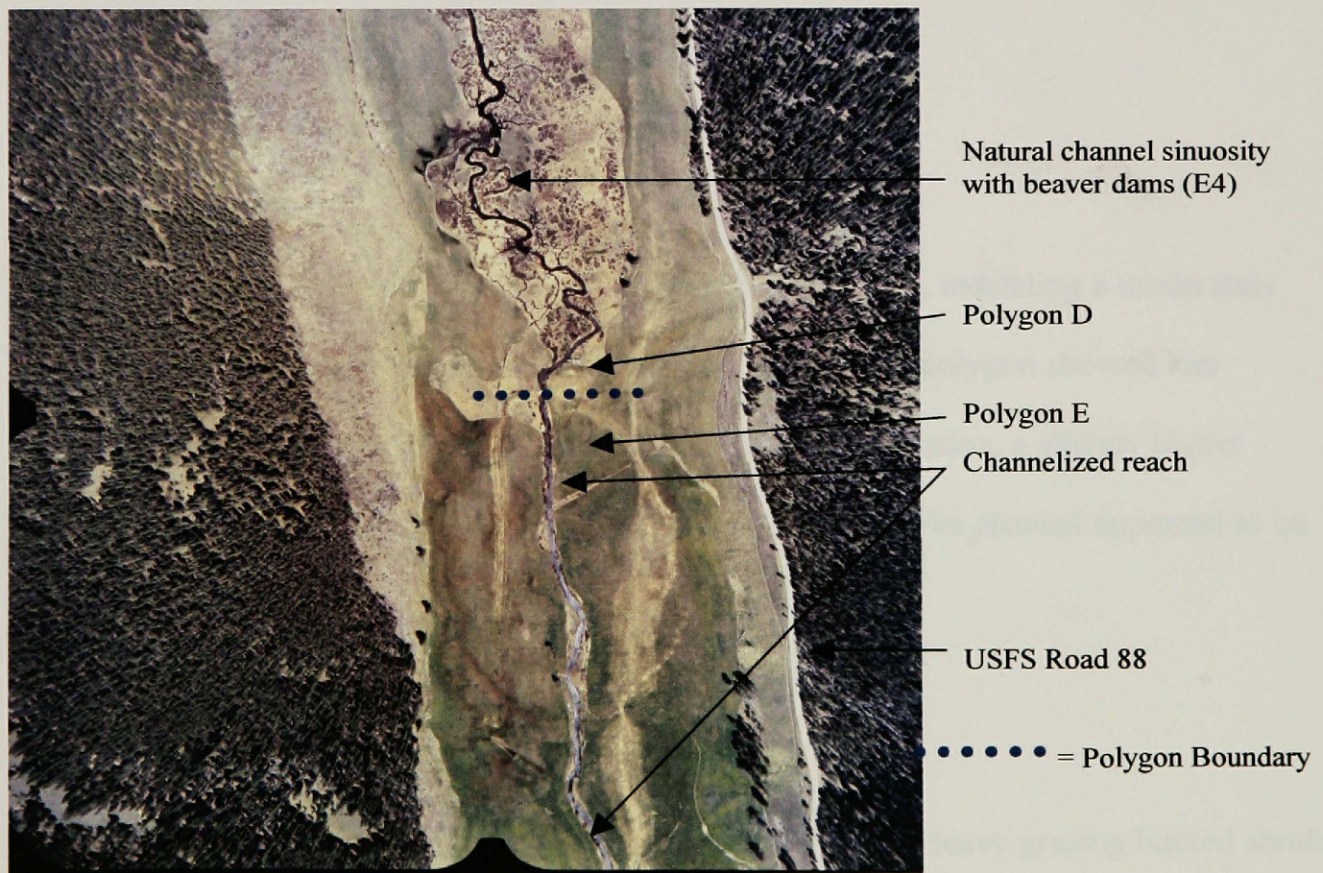
Figure 17 – Aerial photo of R1-R4 Reach 5 and RWRP polygons D and E

Reach 5 extended 8,725 feet (stream mile 9.5 to stream mile 11.2, Miner's Gulch Bridge) and contained RWRP polygons E, F and G. Bank stability (75%), woody composition (28%) and regeneration (34%) were lower than upstream reaches. Approximately 50%

of the channel has been straightened within this reach (Figure 17). Due to channel modifications, riffle composition (45%) was higher than pool (37%). Long stretches of riffles and fast currents limited available fish habitat. Most pool formations resulted from woody root masses (40%), meander scours (33%) and boulders (24%). Maximum pool depth (2.3 ft) dropped slightly and mean water depth remained similar (0.8 ft) to reaches 2, 3 and 4. Large boulders and riprap stabilize two headgate diversion structures and a bridge, causing the channel to be confined. Riparian width was decreased approximately 25' on each side of channel due to adjacent meadows and hay fields along the entire reach. Multiple ditches divert water for irrigation throughout the reach, causing potential sources for trapped fish.

This polygon's low score (54) indicates a riparian area with severely reduced functional capability due to numerous vegetative and soil/hydrologic conditions. Several steeply angled banks were evident where channel incision occurred. This incised channel prevented livestock from easily accessing the stream. The channelized areas within this reach prevent access of the creek to a natural floodplain during high flows. The channel showed early stages of vertical instability and entrenchment due to high water velocities and absence of meander bends. Fortunately, the few remaining riparian shrubs showed light to moderate utilization and provided root mass for bank stability. Grazing pressure has resulted in higher coverage of herbaceous species more common in disturbed sites including Kentucky bluegrass and redtop (*Agrostis stolonifera*). Deep binding root mass was lacking, and decadent shrubs were common.

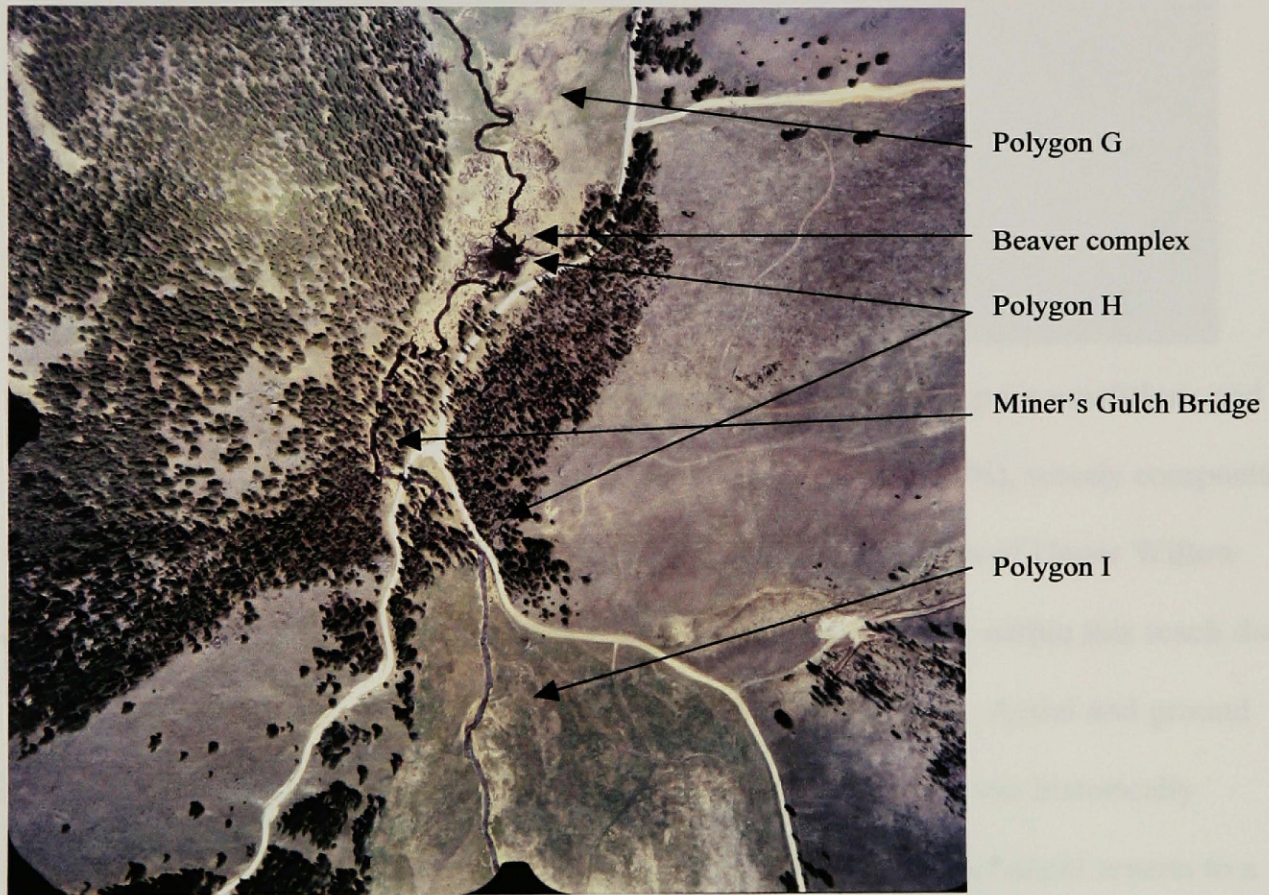
Figure 18 – Aerial photo of RWRP Polygon H.

Reach 6 extended 13,979 feet (stream mile 11.2 to stream mile 13.9, north end of Bohrsen property) and included RWRP polygons H, I, J and K. Polygon H (Figures 18 and 19), owned and managed by the BLM, may serve as a reference reach for a restoration project immediately downstream. Above and below this parcel, the creek flows through privately owned land.

Site F was sampled within the BLM-owned parcel at Miner's Bridge. The valley constricted at this point (Figure 18) creating a slightly steeper gradient. Although W/D ratio increased to 26, sinuosity remained low (1.2) and substrate remained gravel-dominated, indicating a C4 channel.

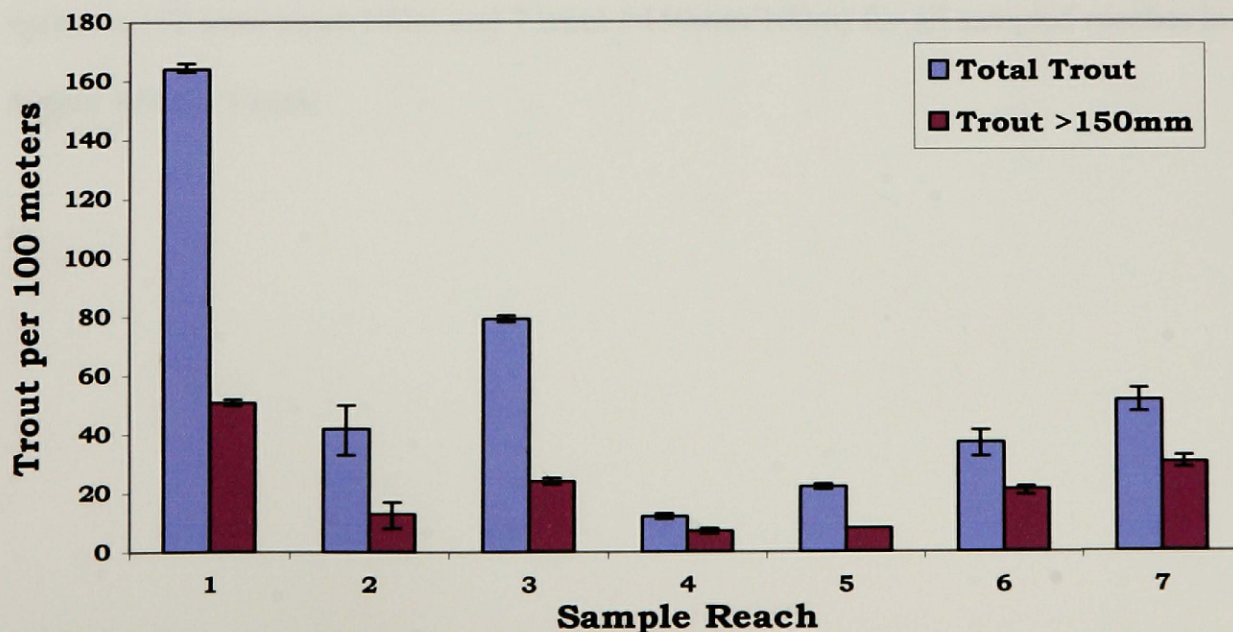
Figure 26 – Population Estimates for Upper Willow Creek Electrofishing Reaches 1-7

Population estimates and catch-per-unit-effort (CPUE) were recorded at each electrofishing transect on Upper Willow Creek (Table 3 and Figure 26). CPUE estimates fish densities by a standard transect length (100m) but are not an accurate depiction of population estimates.

Electrofishing reach 1, located in R1-R4 reach 3 showed the highest population estimate of 164 trout/100m and 51 trout >150mm/100m. Fish in this transect were primarily westslope cutthroat, eastern brook trout and whitefish. Small numbers of brown trout, hybrids, long nosed suckers and sculpins were also present.

Sample reach 3, located in the BLM-managed area at Miner's Gulch Bridge, showed the second highest population estimate of 79 trout/100m and 24 trout >150mm/100m. This sample reach was in a short, but healthy length of creek between two reaches of severely channelized areas (reach 5 and reach 6). Sample reach 3 contained primarily westslope cutthroat and whitefish, but also included one adult bull trout (262 mm). Small numbers of brown trout, rainbow trout and cutthroat/rainbow hybrids were also present. Sample reaches 2 and 4-7 showed lower population estimates of 12-51 trout per 100m and 7-30 trout >150mm per 100m. The primary species were westslope cutthroat trout and whitefish. A total of 11 bull trout were sampled in sample reach 2 and 6 (n=2 and 9, respectively). Sample reach 4 within R1-R4 reach 6 showed the lowest population estimate (12 total trout/100m and 7 trout >150mm/100m) for all sampled reaches in Upper Willow Creek.

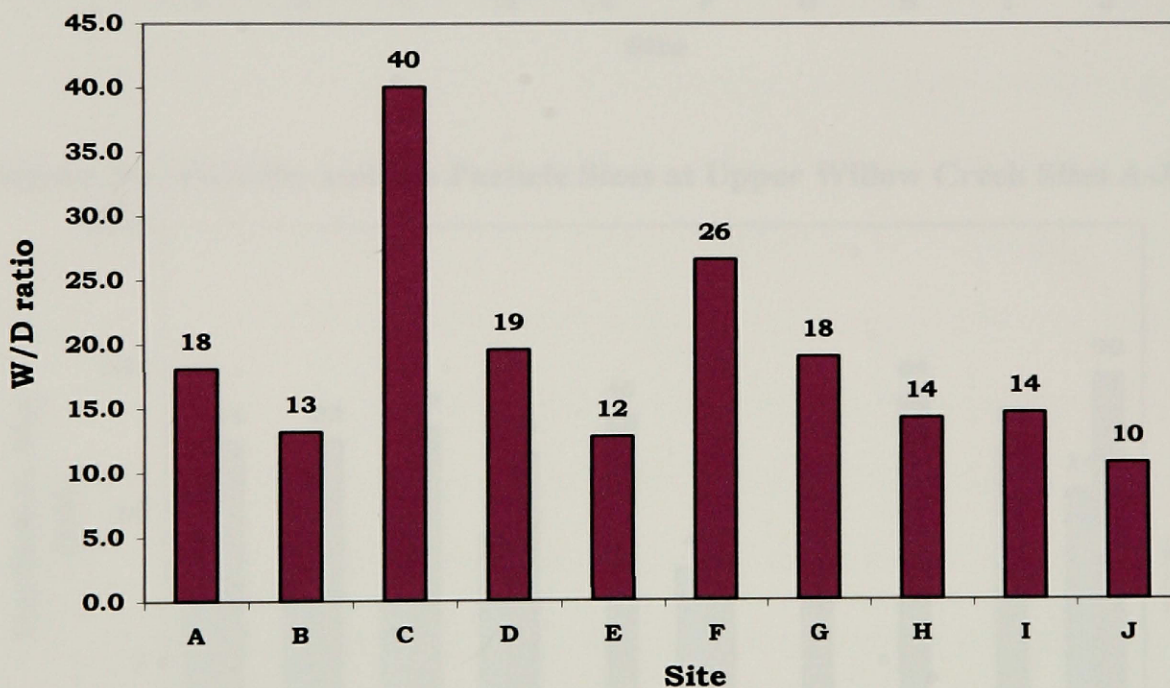
Figure 27 – Width/Depth Ratios at Upper Willow Creek Sites A-J

The morphological characteristics measured in Upper Willow Creek included width/depth ratios (Figure 27), channel substrate (Figures 28 and 29) and sinuosity.

between 1.5 and 2.0 given substrate and valley characteristics. The low sinuosity and W/D ratio (13) suggest a downcutting channel as a result of added energy placed on the bed throughout channelized areas. Average substrate size in pools within this reach dropped to 0.11mm indicating sediment deposition. Although historical, natural conditions would have likely produced either a C4 or E4 channel, current conditions showed characteristics of an incised Rosgen F4 channel.

Sample site H within reach 7 showed similar conditions to sample site G in reach 6. The sinuosity (1.3) and W/D ratio (14) again showed a confined channel attempting to re-establish a natural pattern. Pool substrate showed continued sediment deposition, as D_{50} particles were 0.13mm. The current channel shows characteristics of an incised F4 channel, although natural conditions likely produced a C4/E4 pattern.

Sample site J within reach 10 showed unaltered conditions relative to all mid and lower reaches of Upper Willow Creek. Historically active channels existed across the floodplain (Figure 25). Sinuosity (1.6), W/D ratio (11) and gravel substrates indicated a Rosgen E4 channel. The channel did not show evidence of downcutting and pool particle sizes increased, indicating a decrease in fine sediment deposition (pool D_{50} = 14mm) (Figure 29).

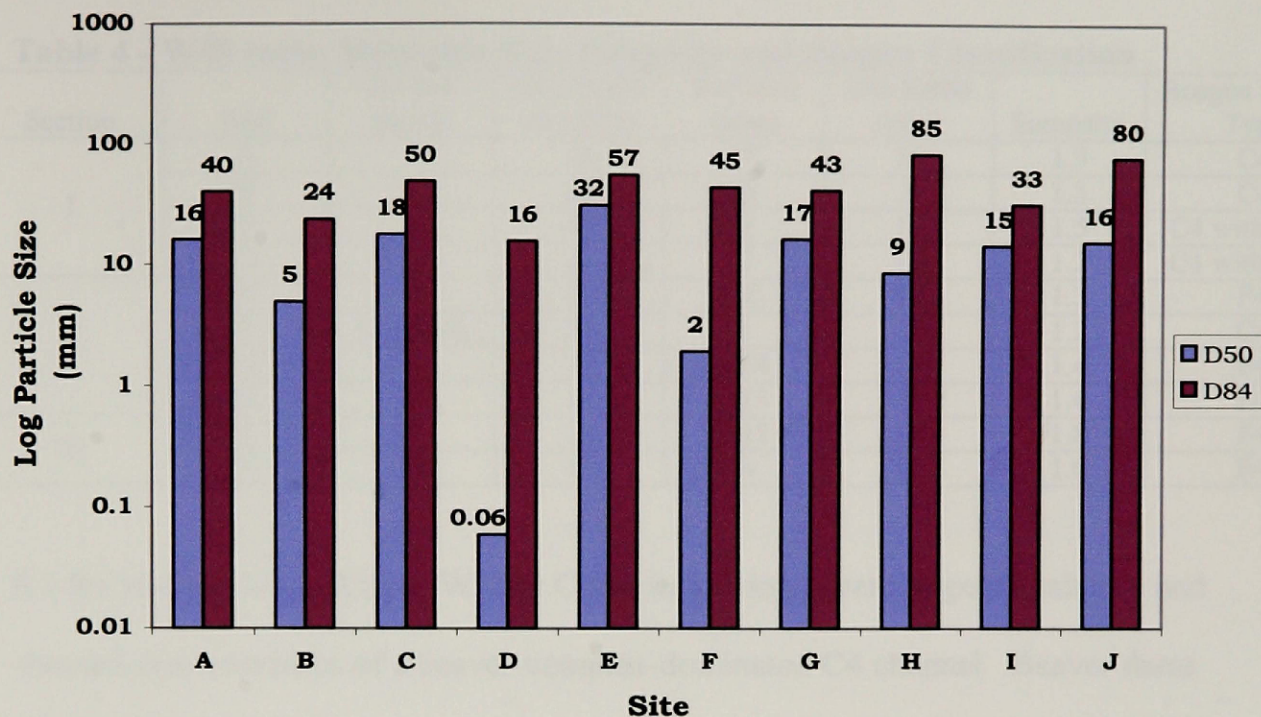
Figure 28 – Riffle D50 and D84 Particle Sizes at Upper Willow Creek Sites A-J

R1-R4 reaches 1-4 of Upper Willow Creek in Section I were largely unaltered and showed characteristics of a beaver-complex-dominated C4 channel. Beaver dams throughout reaches 3 and 4 created difficult sampling conditions due to few adjacent pool/riffle locations. Riffles were sampled immediately below dams upstream of the next pool. This sampling scheme may have had an influence on W/D ratio and substrate results (e.g. W/D ratio 40, site C). Site D showed much smaller riffle D50 particles than pool D50 particles, also likely due to this sampling scheme. Although beaver dams generally create a sediment trap, periodic failures in a dam's structural integrity may lead to sediments being released. Sediments released by failing beaver dams may deposit immediately downstream of the dam if the discharge is incapable of sediment transport, explaining the smaller particle sizes found in site D riffles.

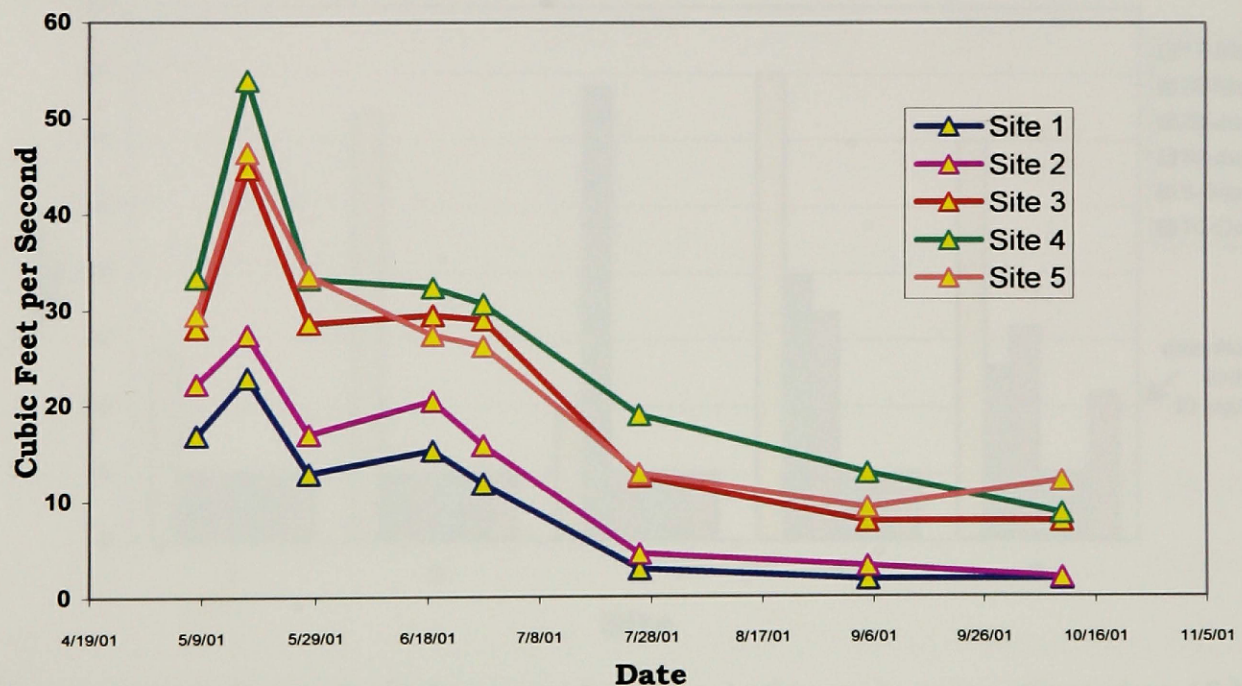
Figure 30 – Discharge of Upper Willow Creek in 2001 at Sites 1-5

Upper Willow Creek discharge was measured at sample sites 1-5 to permit rough estimation of sediment and nutrient loads. Discharge was recorded once or twice per month between 17 May and 10 October 2001 (Figure 30). Discharge peaked on 17 May and reached baseflow levels by 26 July. Discharge increased downstream between sites 1 through 4. Site 5 recorded lower discharge than site 4 except on 17 May and 10 Oct. Although some flows are lost to irrigation in this reach, loss to groundwater is also probable as this area of the basin is considered alluvial class geologic material (Carnefix 2002, Jensen 1998).

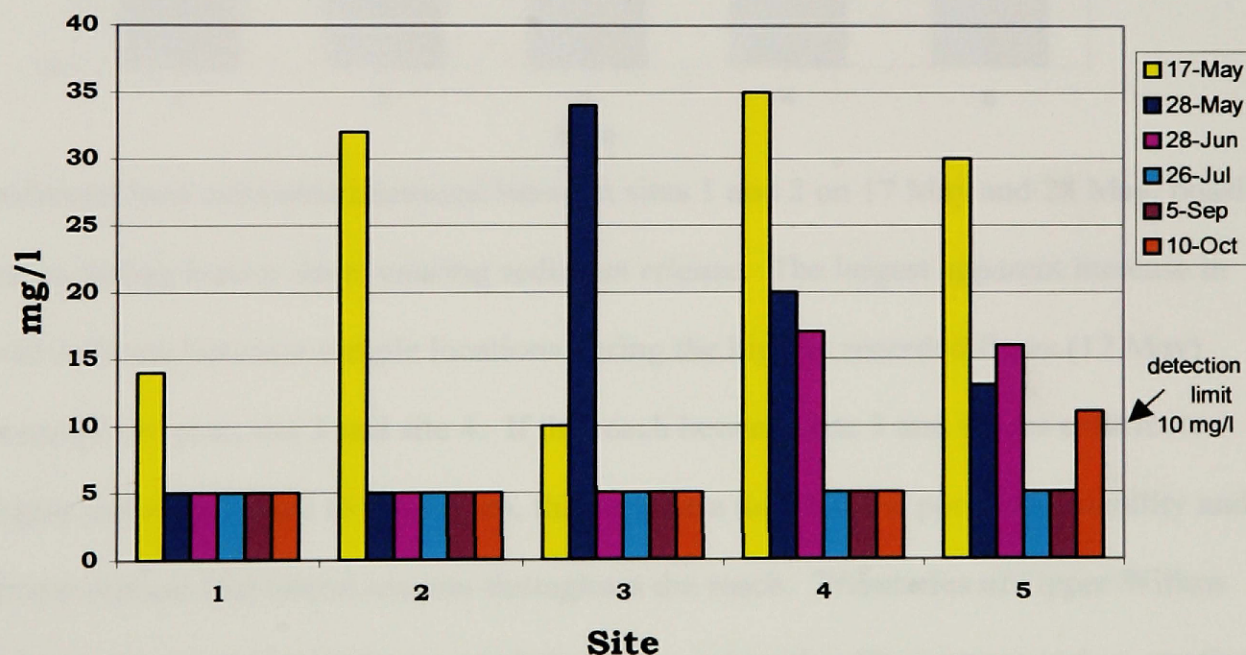
Figure 31 – Total Suspended Sediment Concentration at Upper Willow Creek Sites 1-5

Total suspended sediment (TSS) concentrations for sites 1-5 in Upper Willow Creek appeared to peak on 17 May, during the highest flows recorded for the study (Figure 31).

Sediment concentrations on 17 May ranged from 10 mg/l at site 3 to 35 mg/l at site 4. Site 3 may have produced lower sediment concentrations due to a beaver dam approximately 200 meters upstream of the sample site, providing a sediment trap. This dam was periodically breached by landowners to prevent excessive flooding during high flows. The spike in TSS concentration on 28 May between site 2 and site 3 may have been due to the dam being breached and releasing accumulated sediments. Sediment concentrations decreased at all sample sites after the peak flow. Samples were below the detection limit (10 mg/l) at all samples after the 28 June sample date except on 10 October (all results on figure 24 shown at 5 mg/l were below detection).

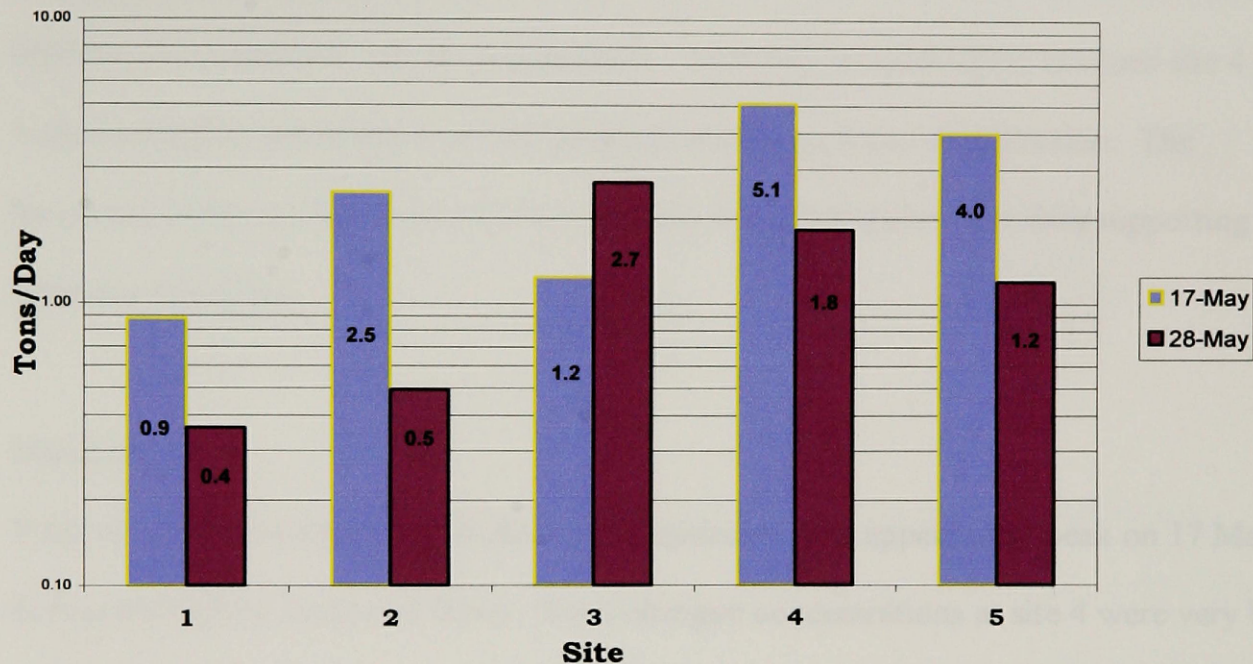
Figure 32 – Sediment Load Estimates During 2001 Peak Flows at Upper Willow Creek Sample Sites 1-5

Sediment loads during the highest recorded flows in this study were estimated on 17 May and 28 May by multiplying sediment concentration by discharge during that sample day (Figure 32). Sediment concentrations at sites 1 and 2 on May 28 were below detection (10 mg/l), therefore a concentration of 5 mg/l was used to estimate sediment loads for

Sediment load estimates increased between sites 1 and 2 on 17 May and 28 May, possibly due to failing beaver dams causing sediment release. The largest apparent increase in load estimate between sample locations during the highest recorded flows (17 May) occurred between site 3 and site 4. If the reach between site 3 and 4 does contribute higher sediment inputs to the stream, this may be a result of the poor bank stability and severe vertical and lateral erosion throughout the reach. Tributaries of Upper Willow Creek were not individually sampled; therefore, external sediment sources (e.g. erosion from logged areas and roads) cannot be quantified. Discharge decreased between 54% and 71% between 17 May and 28 May, but sediment load estimates remained high at site 3, 4 and 5. Although TSS concentrations were below detection at sites 1 and 2 on 28 May, sediment loads were estimated for these sites to compare sediment loads between

sites. These results suggest the reach between site 2 and site 3 contributed the highest sediment inputs to the stream on 28 May. This appears in agreement with the R1-R4 survey, which indicated that the reaches between sites 2 and 3 and between 3 and 4 had the poorest bank stability in Upper Willow Creek. Estimated sediment load decreased between site 4 and site 5 on all sample dates. Substrate samples taken between site 4 and 5 showed higher percentages of fine particles, indicating areas of deposition. The decreased sediment load estimates between site 4 and 5 complements data supporting sediment deposition.

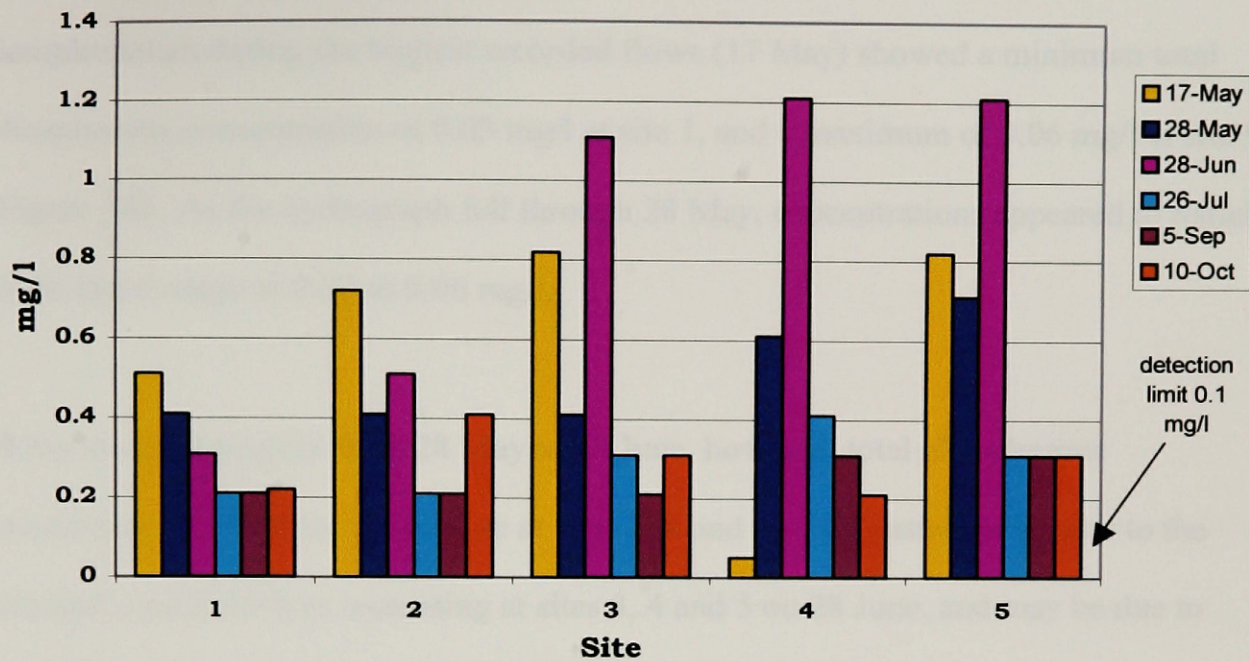
Figure 33 – Total Nitrogen Concentration at Upper Willow Creek Sites 1-5

Total nitrogen concentrations at the 2 most upstream sites appeared to peak on 17 May during the highest measured flows. Total nitrogen concentrations at site 4 were very low compared to other sites on that date, possibly due to an error in sampling or analyzing. Flows dropped by 28 May, and total nitrogen concentrations appeared to drop 10-50% from 17 May levels.

Although flows continued to recede through 28 June, total nitrogen concentrations measured higher at sites 3, 4 and 5, and were the highest recorded throughout the study. Application of fertilizers on private lands downstream of site 2 may explain the higher nitrogen concentrations during 28 June. Several landowners applied fertilizers during this period (Luthje 2001). The highest total nitrogen levels measured at sites 4 and 5 were 1.2 mg/l. Concentrations fluctuated between 0.2 and 0.4 mg/l at all sample sites throughout the remaining dates of 26 July, 5 September and 10 October. Total Kjeldahl nitrogen accounted for most of the total nitrogen. Dissolved nitrogen, in the form of NO_2 and NO_3 was near detection throughout the study. Of 30 nitrate samples, 25 were at or below detection levels (.01 mg/l) (Table 5). Overall, total nitrogen levels were high compared to state nutrient standards for the Clark Fork River. These standards set a target of 300 micrograms/liter (0.3 mg/l) concentration for total nitrogen. Of the 30 samples taken in Upper Willow Creek in 2001, 22 samples exceeded this standard.

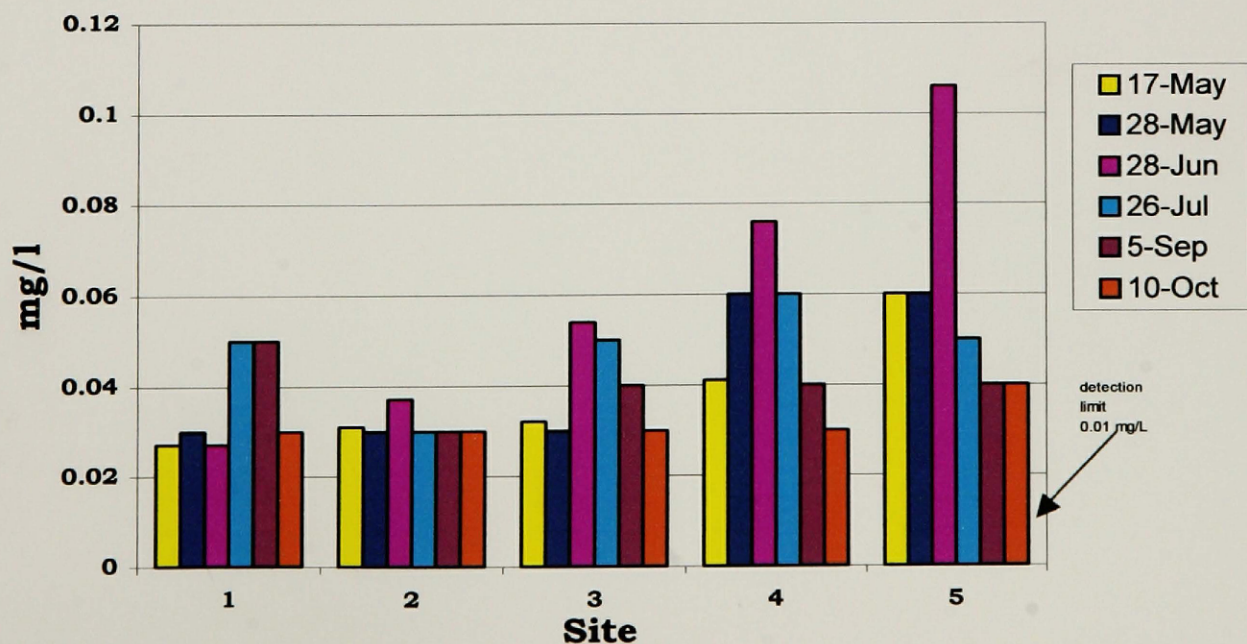
Figure 34 – Total Phosphorous Concentration at Upper Willow Sites 1-5

Samples taken during the highest recorded flows (17 May) showed a minimum total phosphorous concentration of 0.03 mg/l at site 1, and a maximum of 0.06 mg/l at site 5 (Figure 34). As the hydrograph fell through 28 May, concentrations appeared to remain in the same range of 0.03 to 0.06 mg/l.

Flows dropped slightly from 28 May to 28 June, however, total phosphorous concentrations appeared to increase at sites 3, 4 and 5. This pattern is similar to the nitrogen concentrations increasing at sites 3, 4 and 5 on 28 June, and may be due to fertilizer application. Phosphorous concentrations appeared to drop throughout the remainder of the study after 28 June and remained between 0.03 and 0.04 mg/l for all sites during base flows (10 cfs). Most of the TP was in the form of orthophosphates. This was determined by comparing the total phosphorous concentration with the orthophosphate concentrations.

Overall, Upper Willow Creek phosphorous levels were high relative to nutrient standards for the Clark Fork River (Administrative Rules of Montana 17.30.631). These standards set a target of 20 micrograms/liter (0.02 mg/l) total phosphorous from the headwaters of the Clark Fork River to the Blackfoot River confluence (standards apply from June 21st to September 21st). Of the 30 samples taken in Upper Willow Creek in 2001, all 30 exceeded this standard.

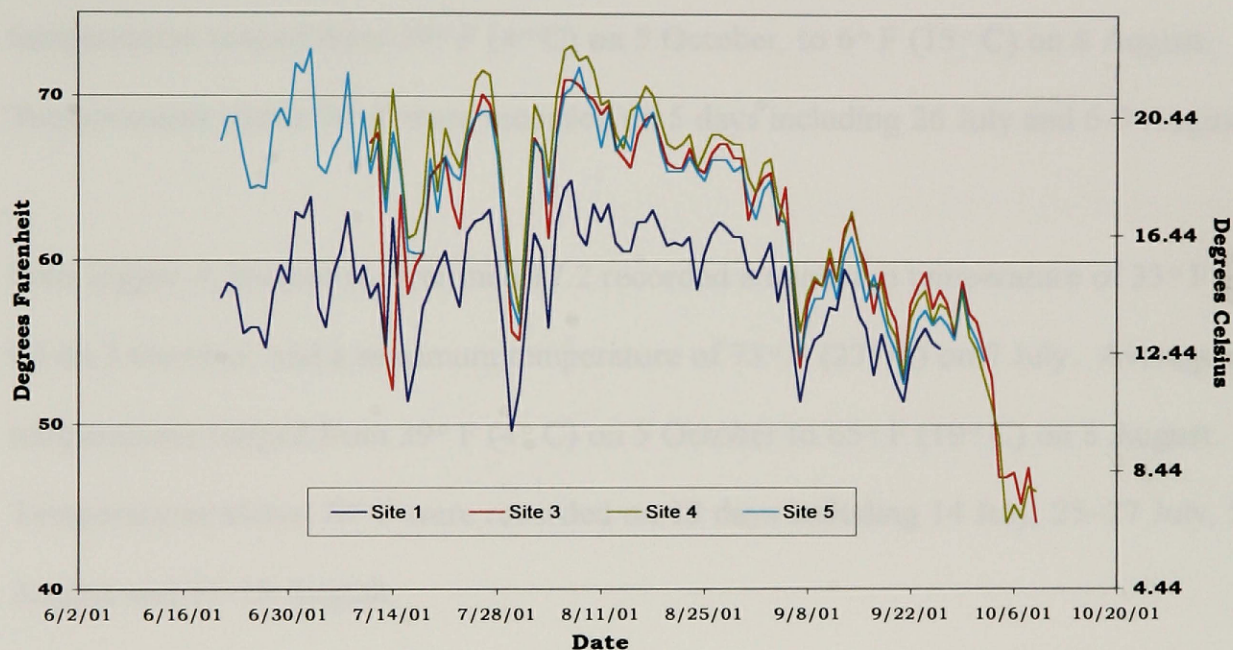
Figure 35 – Maximum Temperatures at Upper Willow Creek Sites 1, 3, 4 and 5

Maximum daily temperatures were recorded at sample sites 1-5 to note the frequency of periods during which the water exceeded 70° F (21° C). Five data loggers recorded maximum water temperatures every 1.5 hours (Figure 35).

Data logger 1, located at river mile 0, recorded a minimum temperature of 38° F (3° C) on 20 September, and a maximum temperature of 65° F (18° C) on August 7th. Average daily temperatures ranged from 45° F (7° C) on 20 September to 56° F (13° C) on 7 August. At no time were temperatures recorded above 70° F at this site.
